MEMORANDUM

TO: Muldoon Creek Water District (37-O) File

SUBJECT: Investigation of Guy Peterson Property

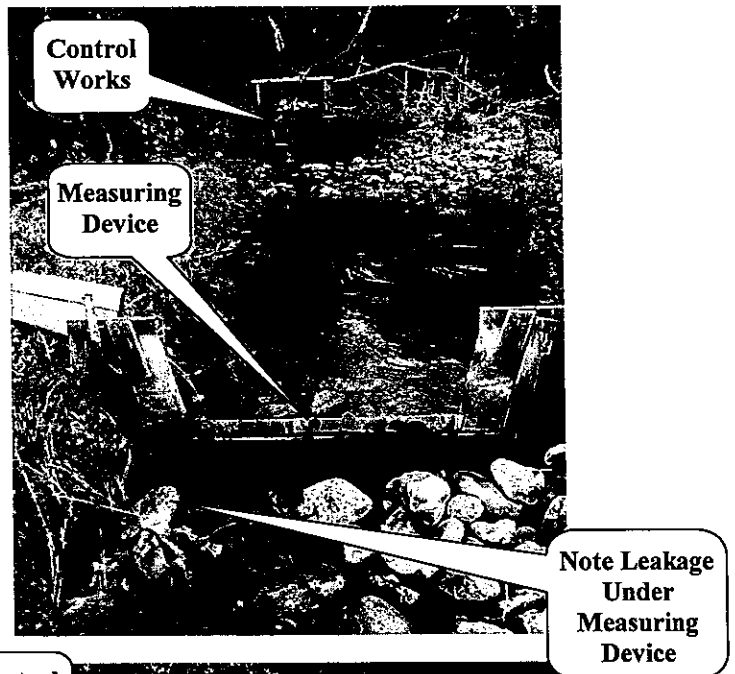
RIGHT: View on 9/5/2007, later in the day (approximately 3 hours and 45 minutes after the top photo was taken), looking up Guy Peterson's main diversion ditch, just below Guy Peterson's Muldoon Creek diversion (Site Tag #A0011848). At the time this photo was taken, water was not flowing over the weir blade. However, note the water flowing under the measuring device.

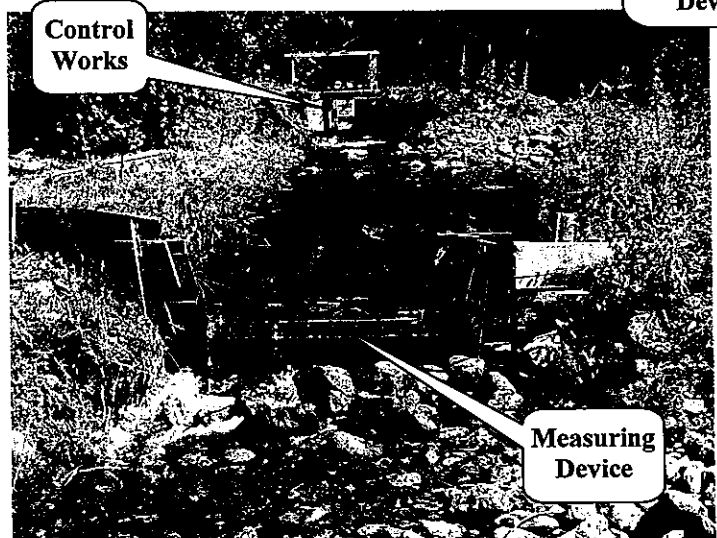
RIGHT: View on 9/6/2007 looking up Guy Peterson's main diversion ditch, just below Guy Peterson's Muldoon Creek diversion (Site Tag #A0011848). At the time this photo was taken, the depth of the flow over the measuring device was once again approximately 2 inches (less than 1.0 cfs total flow).

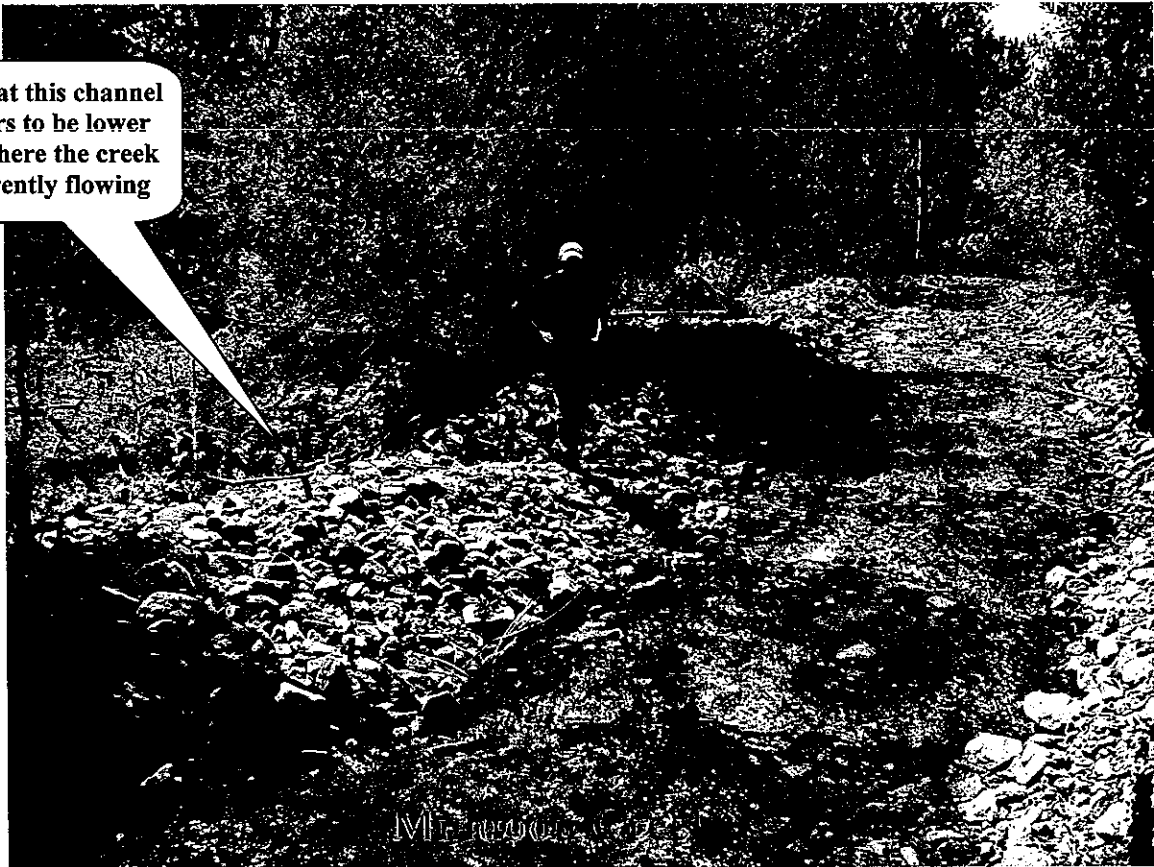
Note that this channel appears to be lower than where the creek is currently flowing

ABOVE: View approximately 420 feet downstream of Guy Peterson's Muldoon Creek diversion (Site Tag #A0011848) shown on previous page. This is the location of a suspected stream channel alteration where it appeared that material has been placed along the left (east) side of Muldoon Creek blocking off a lower channel (indicated by dashed arrow). The material that Jeff is standing on forces Muldoon Creek to the right (west) towards Guy Peterson's main diversion ditch below his Muldoon Creek diversion (Site Tag #A0011848). Note that the material Jeff is standing on appears to have been placed or piled in a linear, unnatural, manner. In addition in the general area where Jeff is standing some signs of cut trees &/or bushes was observed and a couple of small loose pieces of black plastic were observed. The GPS coordinates for this location are 2508771, 1375128 (IDTM coordinates NAD83 projection).

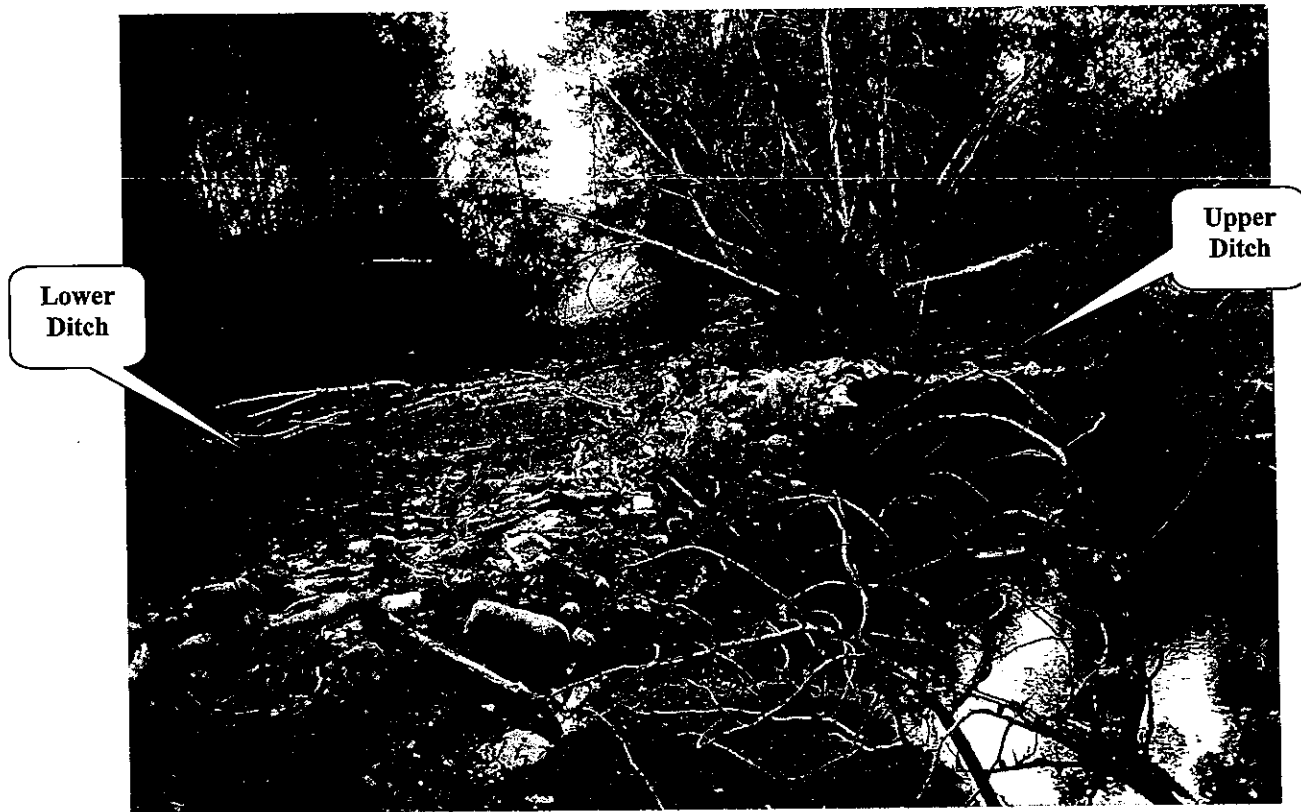
ABOVE: View on 9/5/2007 looking down Guy Peterson's main diversion ditch(es) approximately 1600 feet downstream of Guy Peterson's Muldoon Creek diversion (Site Tag #A0011848) showing the upper and lower delivery ditches (branches off of the main diversion ditch below the point of diversion). This photo was taken approximately one hour after the top photo on page 4 was taken. Estimates of the flow in both of these ditches was made using the "orange peel method" by timing a floating stick through a known length and average cross section for that length. The velocity through a 10-foot section of the upper ditch was 1.42 feet per second (7 seconds for a floating stick to travel the 10 measured feet). The average cross section was 3.75 square feet (9.0 feet wide x 5 inches deep). Since flow equals velocity multiplied by area, the flow through the upper ditch could have been as much as 5.36 cfs (1.42×3.75). However, since the water flows the fastest at the surface and the middle of the ditch, the 5.36 cfs estimate is probably high. Using a standard reduction factor of 60% – 80% indicates that the **flow in the upper ditch was probably in the neighborhood of 3.2 cfs – 4.3 cfs**. The velocity through a 10-foot section of the lower ditch was 1.25 feet per second (8 seconds for a floating stick to travel the 10 measured feet). The average cross section was 2.67 square feet (8.0 feet wide x 4 inches deep). Since flow equals velocity multiplied by area, the flow through the upper ditch could have been as much as 3.33 cfs (1.25×2.67). However, since the water flows the fastest at the surface and the middle of the ditch, the 3.33 cfs estimate is probably high. Using a standard reduction factor of 60% – 80% indicates that the **flow in the lower ditch was probably in the neighborhood of 2.0 cfs – 2.66 cfs**. Note that the total of the flows in the upper and lower ditch are significantly greater than the amount of water being diverted at Guy Peterson's Muldoon Creek diversion (2 inches of head over a 3.0 foot Cipoletti weir plus leakage under the measuring device).

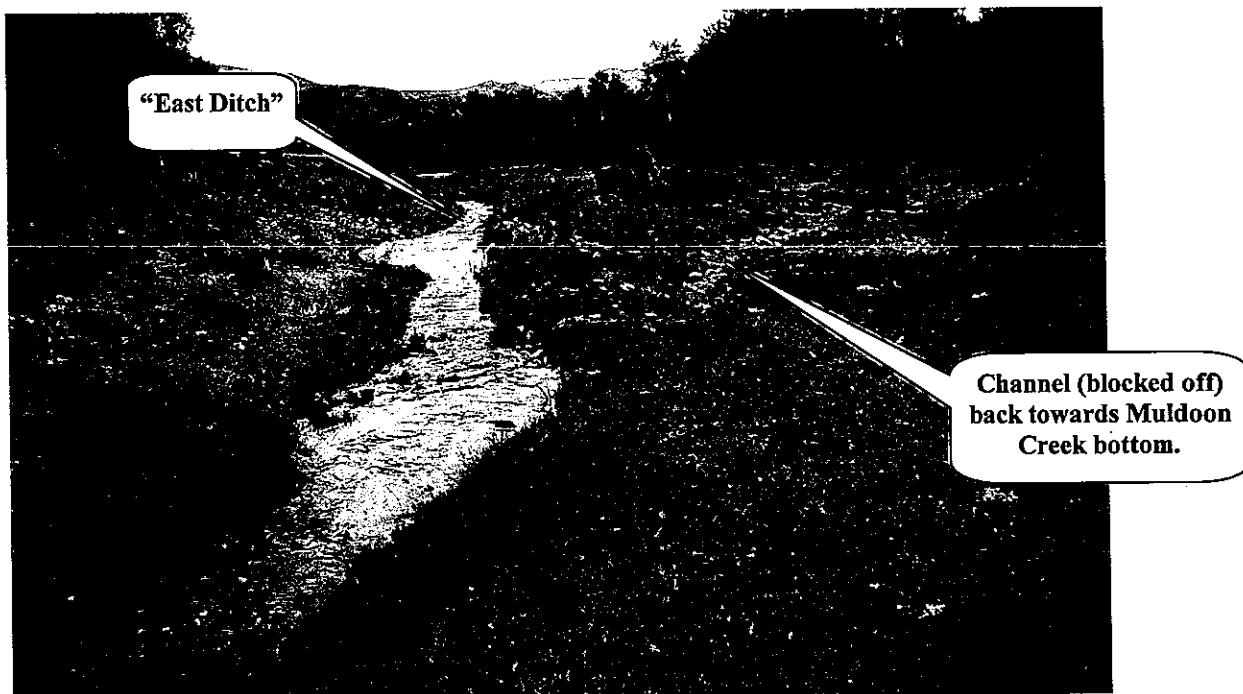
ABOVE: View on 9/5/2007 of flow in the “East Ditch” along the east side of Muldoon Creek. This ditch runs along the hillside towards the mouth of Buck Canyon. Water from this ditch is apparently used to irrigate approximately five acres of pasture. However, note that Guy Peterson does not have any water right (s) that allow for the diversion and use of water from Muldoon Creek on the east side of the creek. An estimate of the flow in this ditch was made using the “orange peel method” by timing a floating stick through a known length and average cross section for that length. The velocity through a 10-foot section of this ditch was 2.5 feet per second (4 seconds for a floating stick to travel the 10 measured feet). The average cross section was 2.13 square feet (3.0 feet wide x 8.5 inches deep). Since flow equals velocity multiplied by area, the flow through this ditch could have been as much as 5.33 cfs.

However, since the water flows the fastest at the surface and the middle of the ditch, the 5.33 cfs estimate is probably high. Using a standard reduction factor of 60% – 80% indicates that the **flow in this ditch was probably in the neighborhood of 3.2 cfs – 4.3 cfs.**

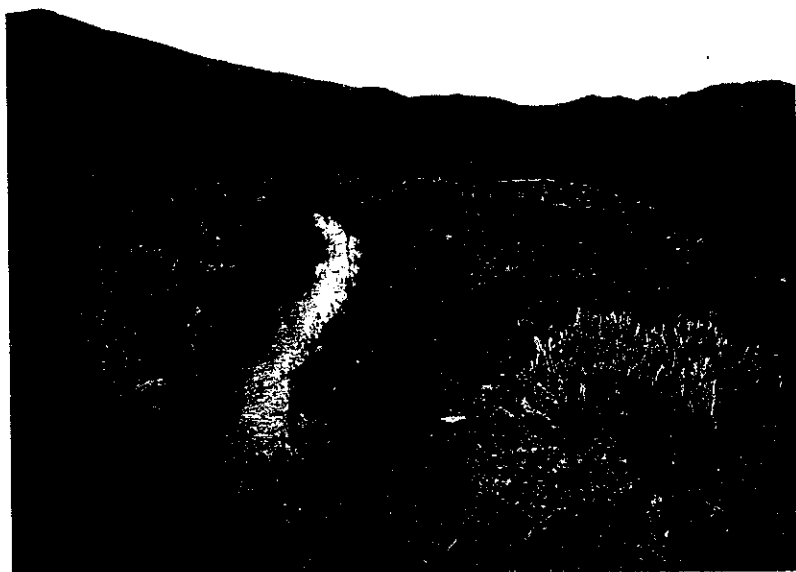
LEFT: View on 9/5/2007 further down the “East Ditch” showing the ditch contouring around the hill towards the Buck Canyon drainage. Note how much higher the ditch is above the Muldoon Creek bottom (right edge of view).

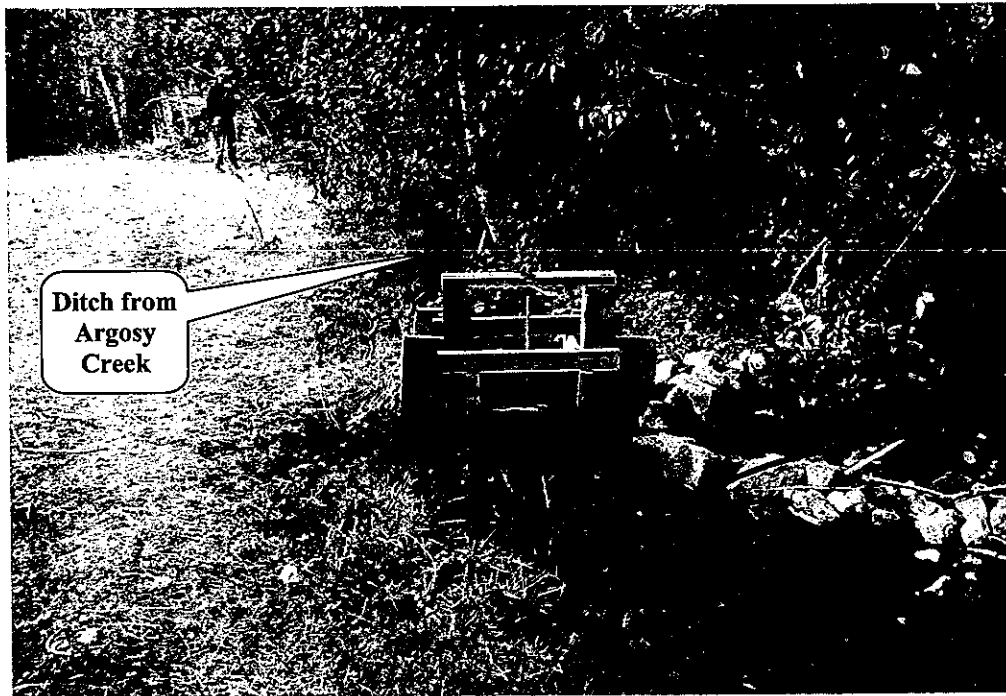
ABOVE: View on 9/5/2007 looking at Guy Peterson's diversion from Argosy Creek (Site Tag #A0016200). SRBA recommendation 37-12392 (0.26 cfs & 1959 priority) is the only right authorized at this particular diversion. Jeff is standing at the approximate location of the measuring device on Guy Peterson's ditch from Argosy Creek (view shown below). At the time this photo was taken, a minimal amount of water was being diverted at this diversion.

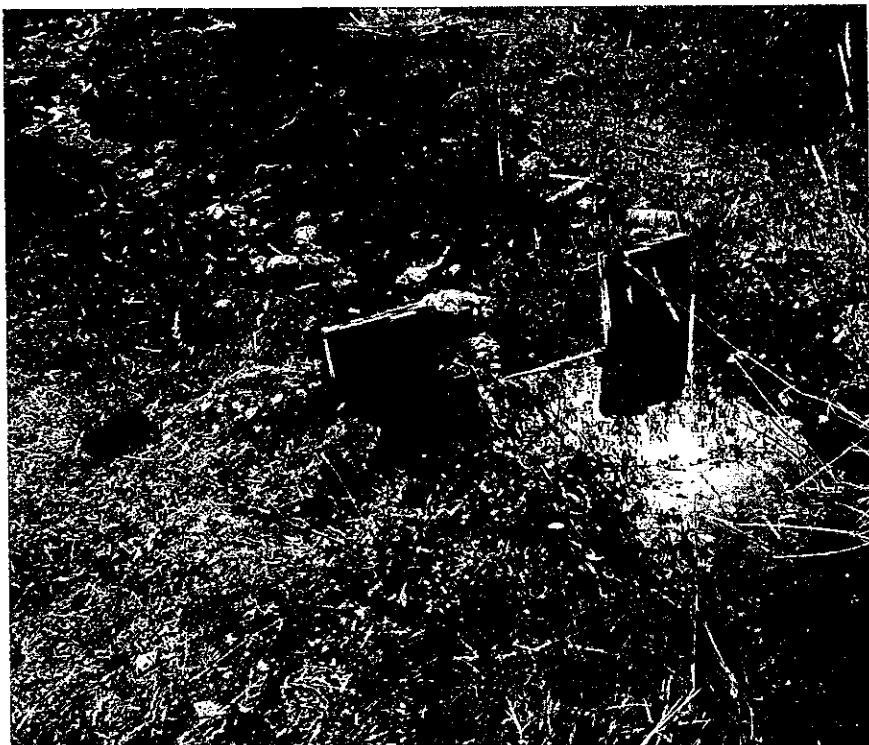
LEFT: View on 9/5/2007 looking at Guy Peterson's measuring device on his ditch from Argosy Creek. The measuring device consists of a rectangular weir with an opening width of approximately two feet (not actually measured since the tape measure was left in the truck). There was just a small amount of water flowing over the device (approximately $\frac{1}{4}$ inch of head). However, it appeared that the water had recently been shut off since the measuring device was wet at a higher level than the level at the time this picture was taken. In addition, rocks above the water level in the ditch were wet.

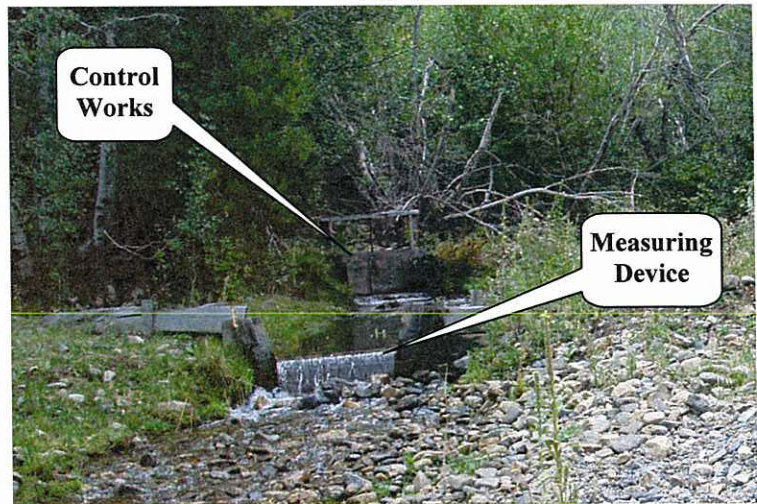
RIGHT: View on 9/5/2007 looking up Guy Peterson's main diversion ditch, just below Guy Peterson's Muldoon Creek diversion (Site Tag #A0011848). At the time this photo was taken, middle of the day on September 5th, the depth of the flow over the measuring device (3.0 foot Cipoletti weir) was approximately 2 inches (less than 1.0 cfs total flow). SRBA Recommendations 37-1143 (2.8 cfs & 1910 priority in the name of Guy Peterson), 37-22107 (1.81 cfs & 1966 priority in the name of Guy Peterson), and 37-22108 (0.07 cfs & 1966 priority in the name of Muldoon Grazing Association) are the only rights that can be diverted from this diversion. In addition, this is the only diversion listed on the same three SRBA recommendations.

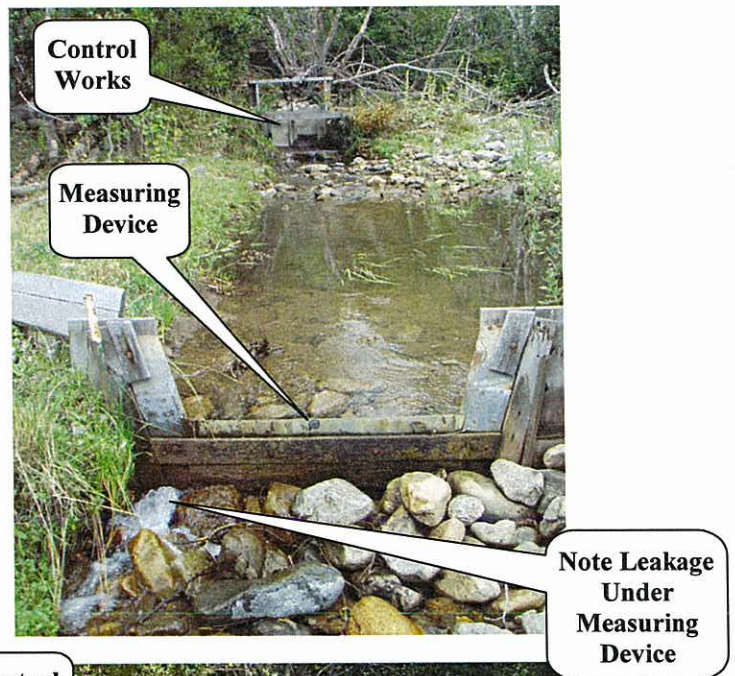
RIGHT: View on 9/5/2007, later in the day (*approximately 3 hours and 45 minutes after the top photo was taken*), looking up Guy Peterson's main diversion ditch, just below Guy Peterson's Muldoon Creek diversion (Site Tag #A0011848). At the time this photo was taken, water was not flowing over the weir blade. However, note the water flowing under the measuring device.

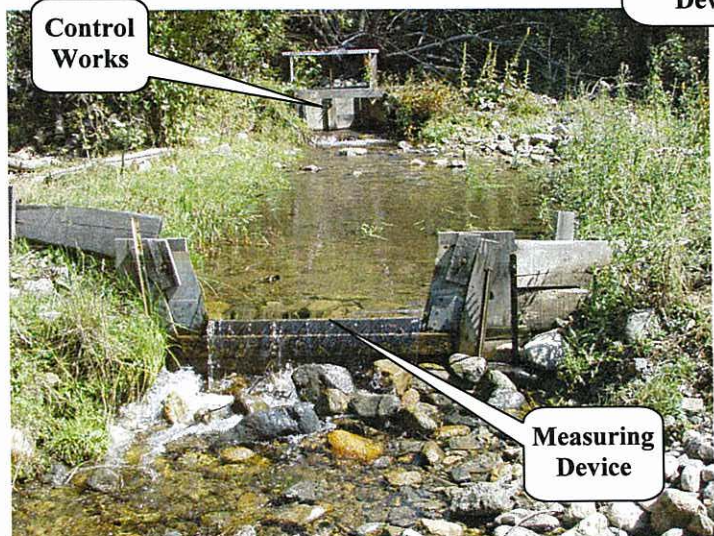
RIGHT: View on 9/6/2007 looking up Guy Peterson's main diversion ditch, just below Guy Peterson's Muldoon Creek diversion (Site Tag #A0011848). At the time this photo was taken, the depth of the flow over the measuring device was once again approximately 2 inches (less than 1.0 cfs total flow).

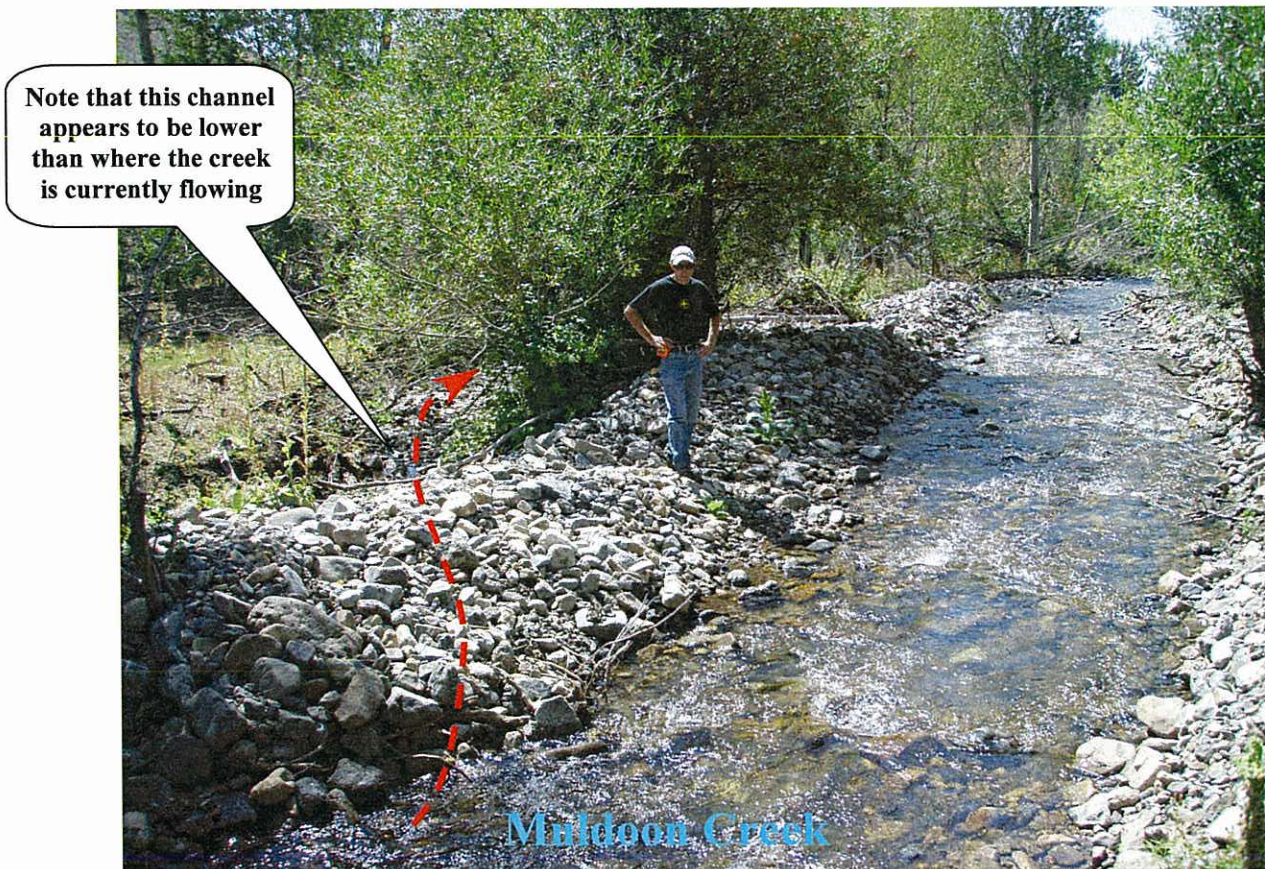
ABOVE: View approximately 420 feet downstream of Guy Peterson's Muldoon Creek diversion (Site Tag #A0011848) shown on previous page. This is the location of a suspected stream channel alteration where it appeared that material has been placed along the left (east) side of Muldoon Creek blocking off a lower channel (indicated by dashed arrow). The material that Jeff is standing on forces Muldoon Creek to the right (west) towards Guy Peterson's main diversion ditch below his Muldoon Creek diversion (Site Tag #A0011848). Note that the material Jeff is standing on appears to have been placed or piled in a linear, unnatural, manner. In addition in the general area where Jeff is standing some signs of cut trees &/or bushes was observed and a couple of small loose pieces of black plastic were observed. The GPS coordinates for this location are 2508771, 1375128 (IDTM coordinates NAD83 projection).

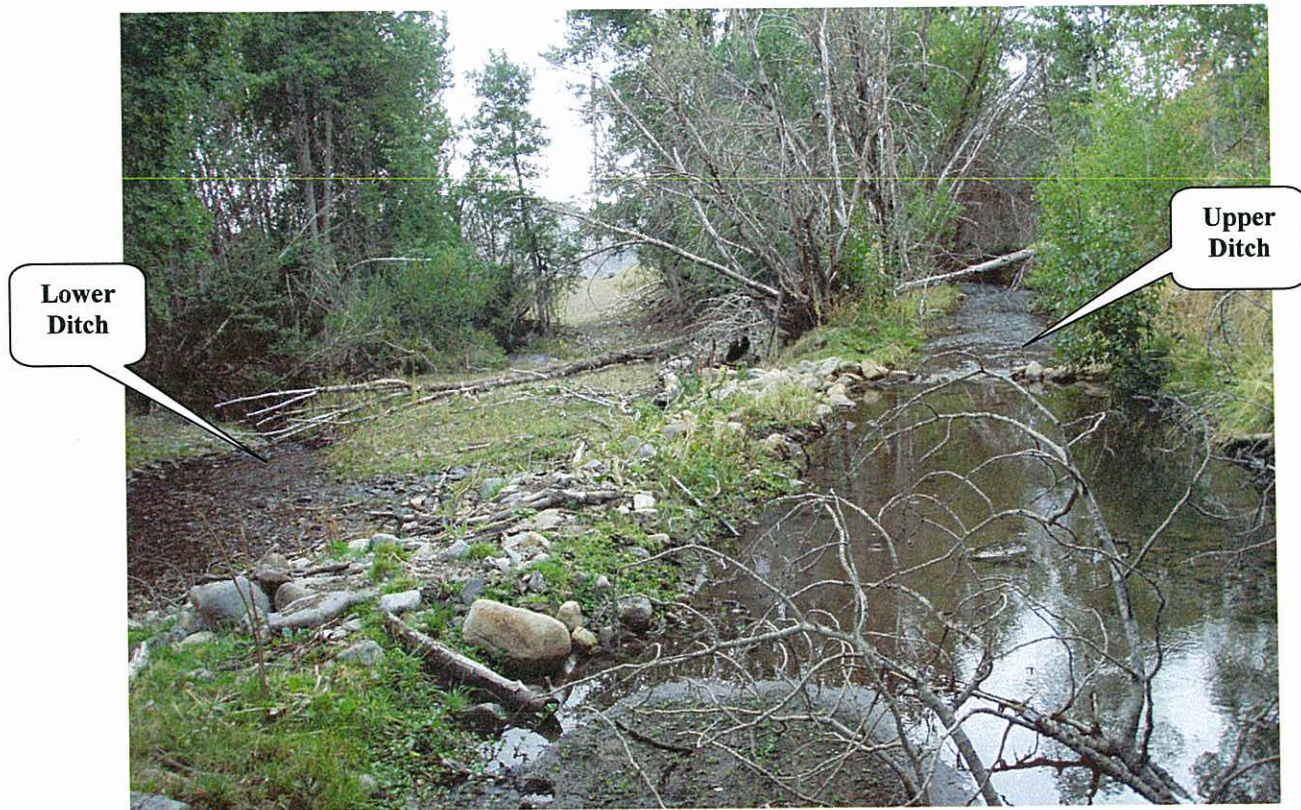
ABOVE: View on 9/5/2007 looking down Guy Peterson's main diversion ditch(es) approximately 1600 feet downstream of Guy Peterson's Muldoon Creek diversion (Site Tag #A0011848) showing the upper and lower delivery ditches (branches off of the main diversion ditch below the point of diversion). This photo was taken approximately one hour after the top photo on page 4 was taken. Estimates of the flow in both of these ditches was made using the "orange peel method" by timing a floating stick through a known length and average cross section for that length. The velocity through a 10-foot section of the upper ditch was 1.42 feet per second (7 seconds for a floating stick to travel the 10 measured feet). The average cross section was 3.75 square feet (9.0 feet wide x 5 inches deep). Since flow equals velocity multiplied by area, the flow through the upper ditch could have been as much as 5.36 cfs (1.42 x 3.75). However, since the water flows the fastest at the surface and the middle of the ditch, the 5.36 cfs estimate is probably high. Using a standard reduction factor of 60% – 80% indicates that the **flow in the upper ditch was probably in the neighborhood of 3.2 cfs – 4.3 cfs**. The velocity through a 10-foot section of the lower ditch was 1.25 feet per second (8 seconds for a floating stick to travel the 10 measured feet). The average cross section was 2.67 square feet (8.0 feet wide x 4 inches deep). Since flow equals velocity multiplied by area, the flow through the upper ditch could have been as much as 3.33 cfs (1.25 x 2.67). However, since the water flows the fastest at the surface and the middle of the ditch, the 3.33 cfs estimate is probably high. Using a standard reduction factor of 60% – 80% indicates that the **flow in the lower ditch was probably in the neighborhood of 2.0 cfs – 2.66 cfs**. Note that the total of the flows in the upper and lower ditch are significantly greater than the amount of water being diverted at Guy Peterson's Muldoon Creek diversion (2 inches of head over a 3.0 foot Cipoletti weir plus leakage under the measuring device).

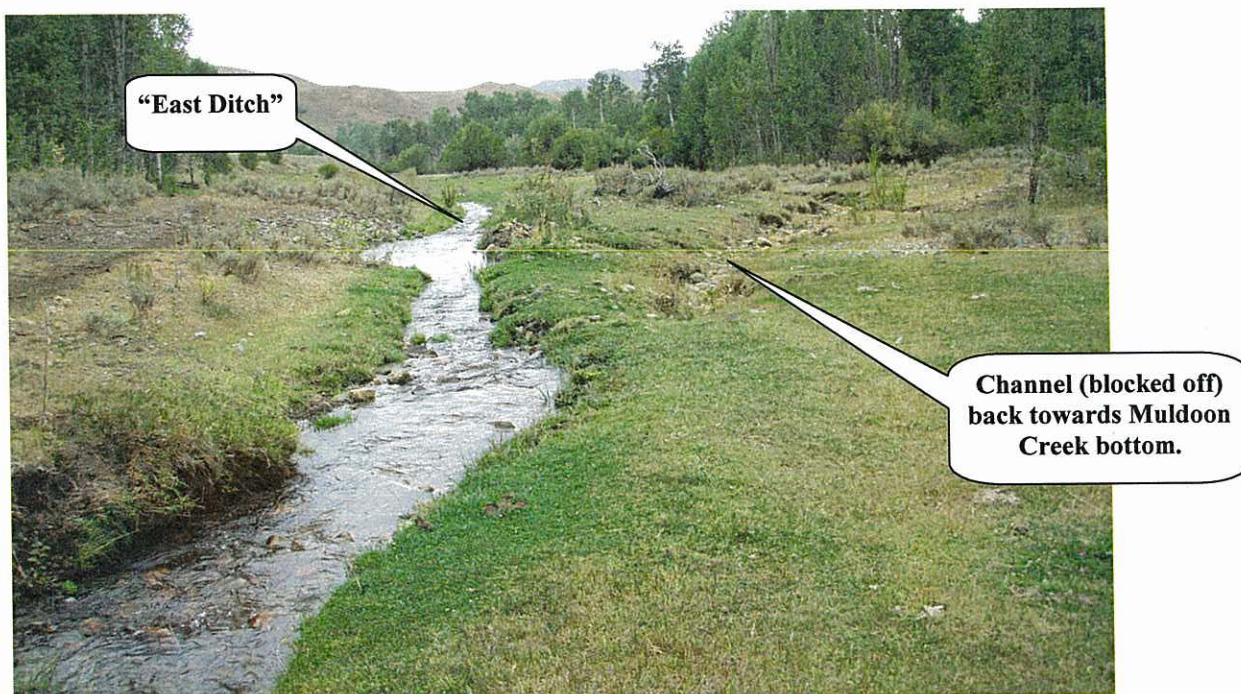
ABOVE: View on 9/5/2007 of flow in the “East Ditch” along the east side of Muldoon Creek. This ditch runs along the hillside towards the mouth of Buck Canyon. Water from this ditch is apparently used to irrigate approximately five acres of pasture. However, note that Guy Peterson does not have any water right (s) that allow for the diversion and use of water from Muldoon Creek on the east side of the creek. An estimate of the flow in this ditch was made using the “orange peel method” by timing a floating stick through a known length and average cross section for that length. The velocity through a 10-foot section of this ditch was 2.5 feet per second (4 seconds for a floating stick to travel the 10 measured feet). The average cross section was 2.13 square feet (3.0 feet wide x 8.5 inches deep). Since flow equals velocity multiplied by area, the flow through this ditch could have been as much as 5.33 cfs.

However, since the water flows the fastest at the surface and the middle of the ditch, the 5.33 cfs estimate is probably high. Using a standard reduction factor of 60% – 80% indicates that the **flow in this ditch was probably in the neighborhood of 3.2 cfs – 4.3 cfs.**

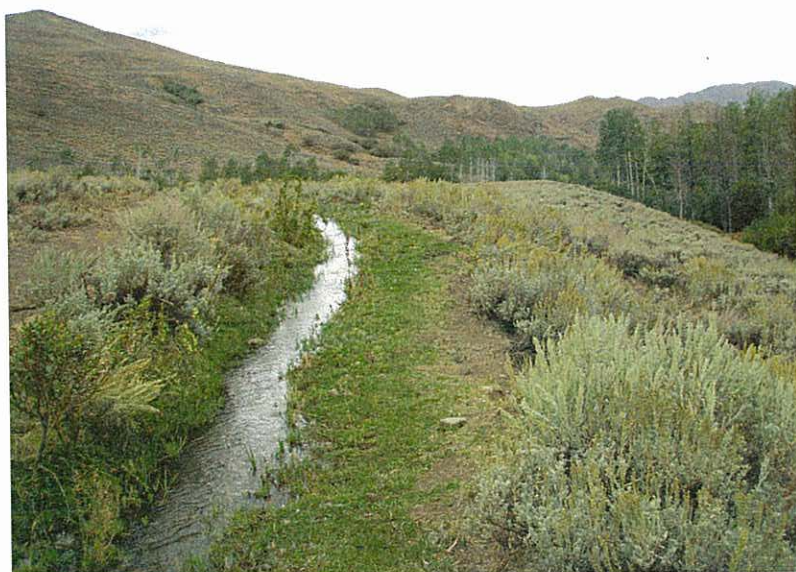
LEFT: View on 9/5/2007 further down the “East Ditch” showing the ditch contouring around the hill towards the Buck Canyon drainage. Note how much higher the ditch is above the Muldoon Creek bottom (right edge of view).

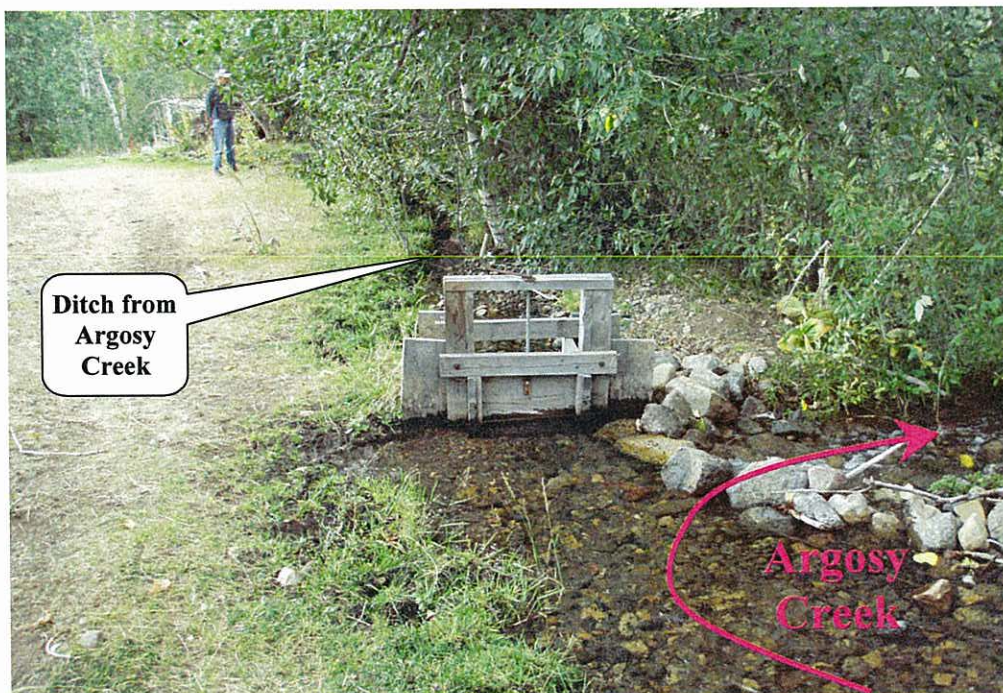
ABOVE: View on 9/5/2007 looking at Guy Peterson's diversion from Argosy Creek (Site Tag #A0016200). SRBA recommendation 37-12392 (0.26 cfs & 1959 priority) is the only right authorized at this particular diversion. Jeff is standing at the approximate location of the measuring device on Guy Peterson's ditch from Argosy Creek (view shown below). At the time this photo was taken, a minimal amount of water was being diverted at this diversion.

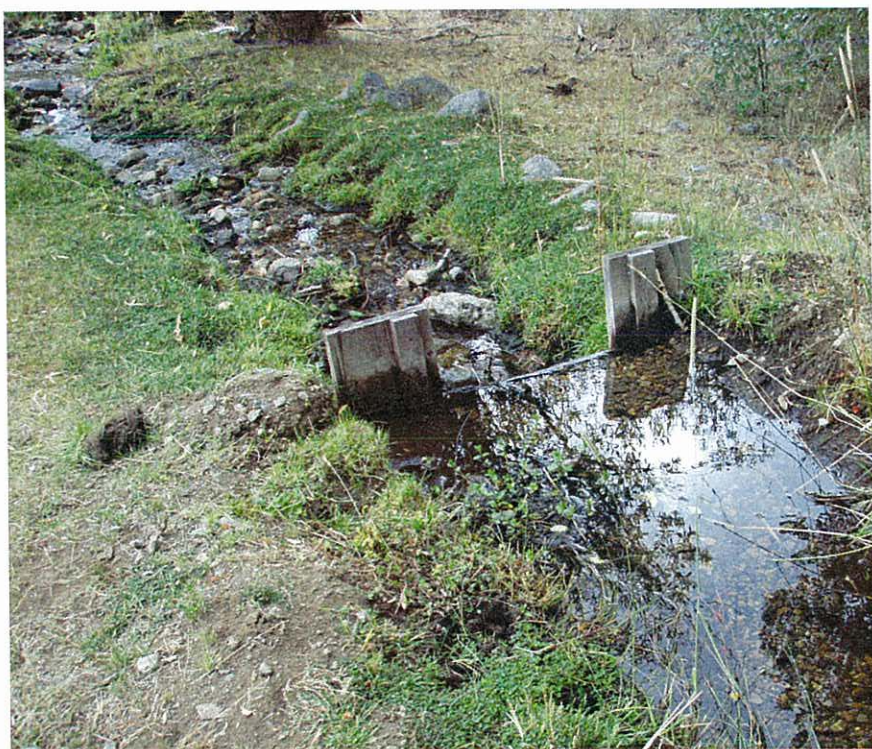
LEFT: View on 9/5/2007 looking at Guy Peterson's measuring device on his ditch from Argosy Creek. The measuring device consists of a rectangular weir with an opening width of approximately two feet (not actually measured since the tape measure was left in the truck). There was just a small amount of water flowing over the device (approximately $\frac{1}{4}$ inch of head). However, it appeared that the water had recently been shut off since the measuring device was wet at a higher level than the level at the time this picture was taken. In addition, rocks above the water level in the ditch were wet.
